MSC-02680

# NATIONAL AERONAUTICS AND SPACE ADMINISTRATION

## APOLLO 13 MISSION REPORT

SEPTEMBER 1970

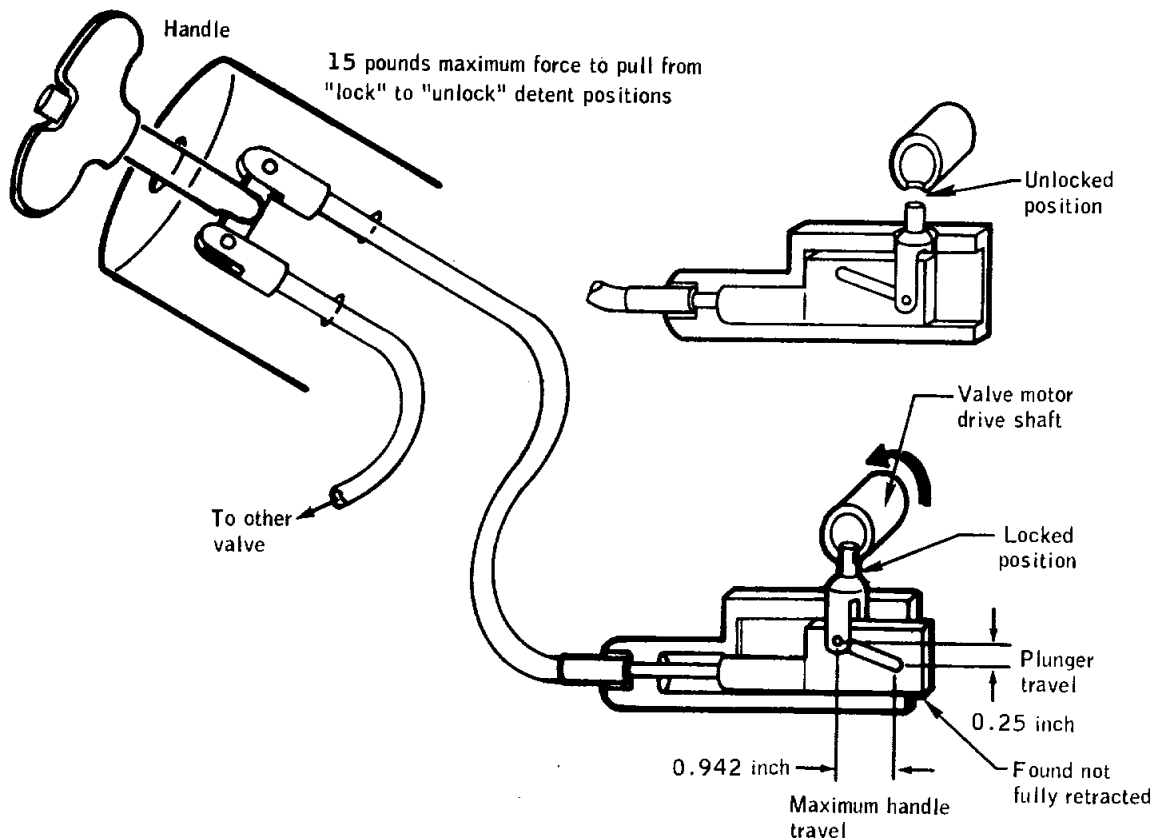
Figure 14-1.- Post-landing vent valve lock.

Upon recovery, the outlet valve of the postlanding ventilation was open and the inlet valve was closed, whereas both valves should have been open. This condition is reported in section 10.3.2, and the anomaly is discussed in section 14.1.2.

The valve-lock mechanism rigging tolerances were found to be within specifications. When reassembled in the spacecraft, the malfunction was duplicated with only partial travel of the handle.

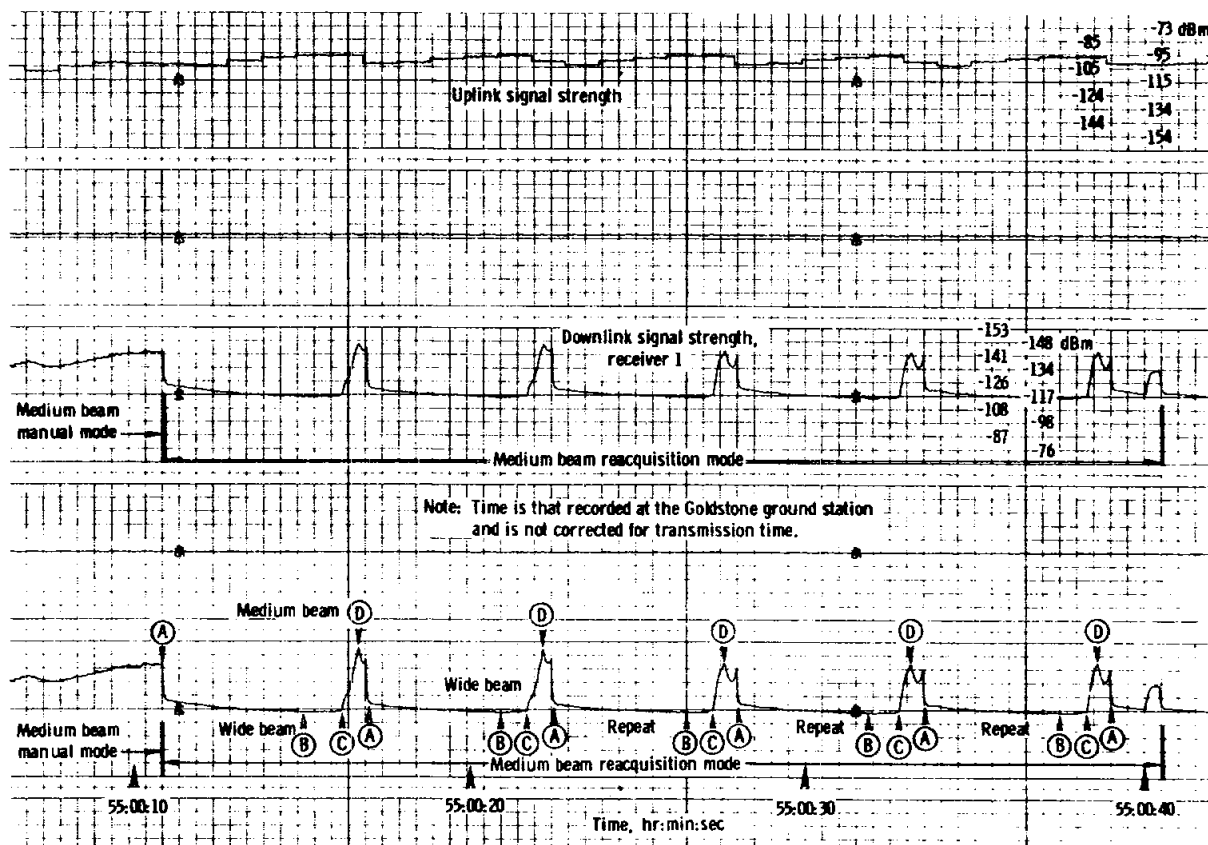
Figure 14-6.- Recorded signal strengths during high-gain antenna operation.

results of this test shifted the scan-limit functions but did not produce the necessary change in the scan-limit slope. Consequently, a failure in the electronic box is ruled out.

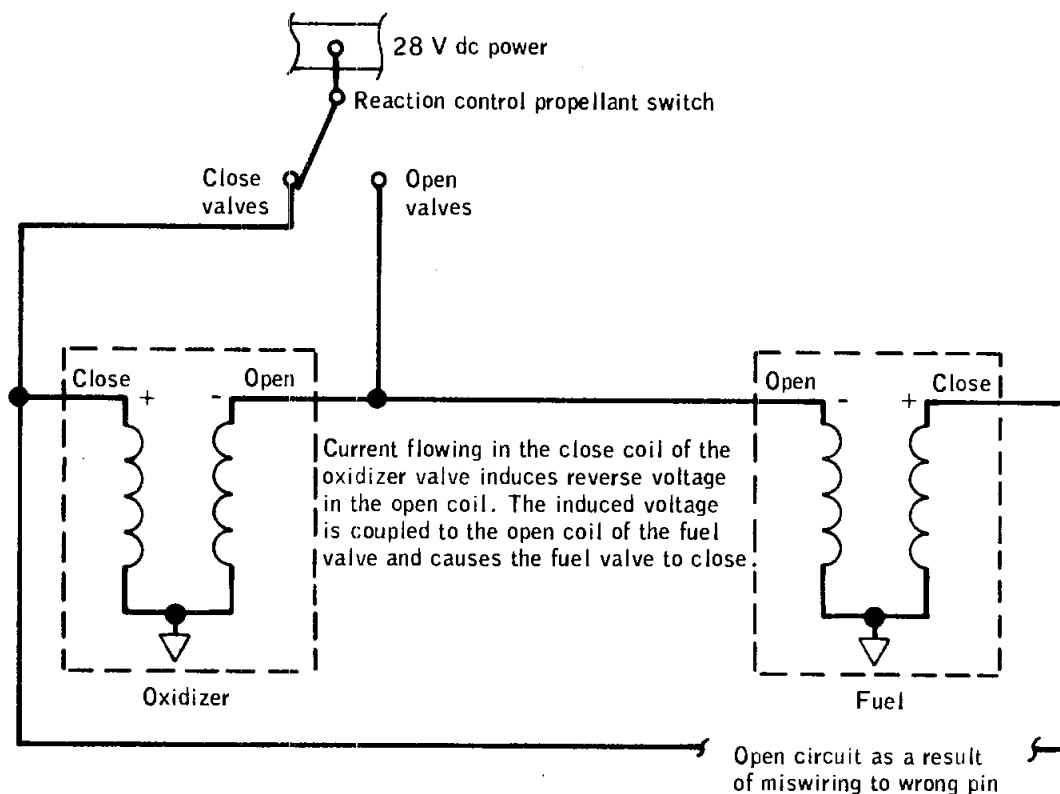
Figure 14-11.- Isolation valve circuit.

System decontamination at Hawaii was normal, except that the system 1 fuel isolation valve was found to be in the open position. All other propellant isolation valves were in the normal (closed) position. Power from ground servicing equipment was used to close the valve, which operated normally. Postflight investigation of this condition revealed that the electrical lead from the system 1 fuel-valve closing coil was miswired, making it impossible to apply power to this coil. This anomaly is discussed in section 14.1.7.

action. This voltage is applied to the fuel valve opening coil where it induces a magnetic field flux that closes the fuel valve. With 28 volts or more on the spacecraft bus, this phenomenon was consistently repeatable. With 24 to 28 volts on the bus, the valve would occasionally close, and with less than 24 volts, the valve would not close. Since preflight testing is accomplished at 28 volts, the functional tests did not disclose the miswiring. During the mission, the voltage was such that the valve did not close when commanded and therefore was found open after the flight.

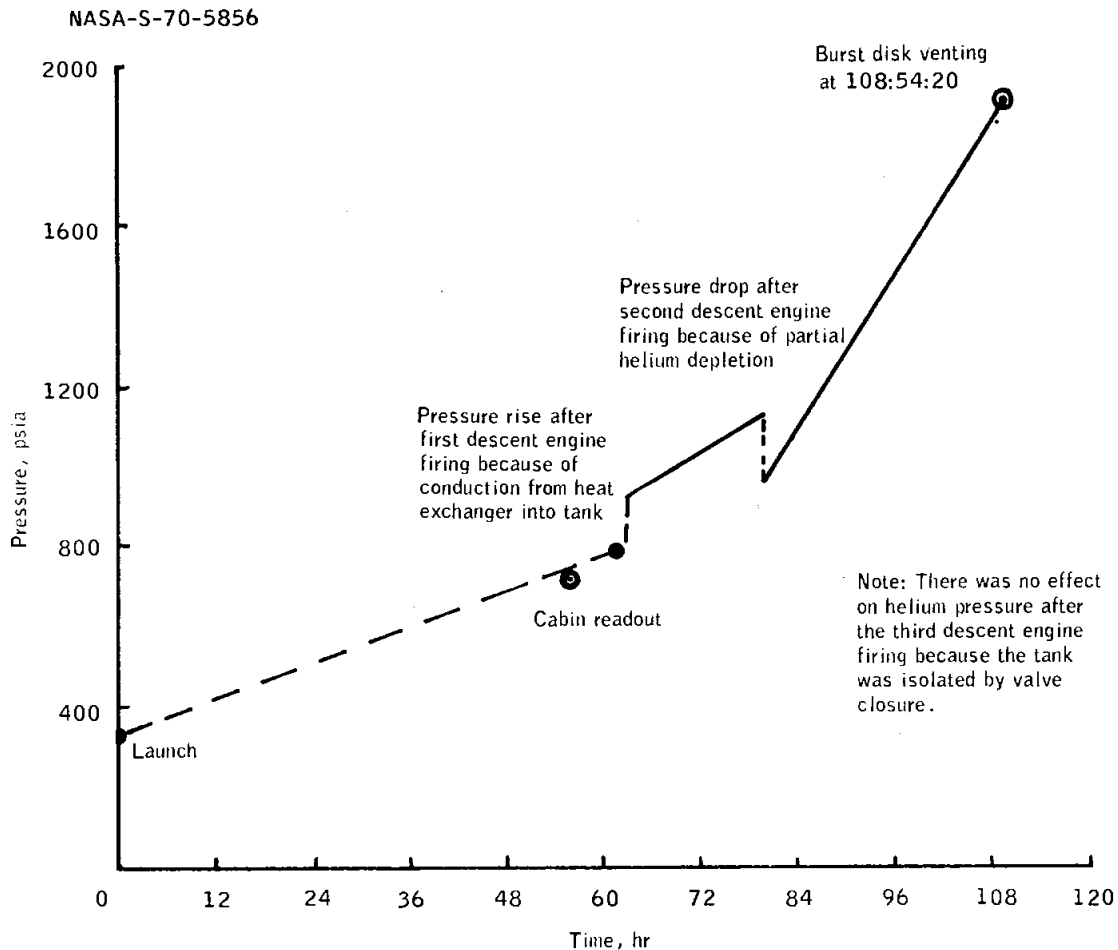
Figure 14-14.- Inflight profile of supercritical helium tank pressure.

The most likely cause of the anomaly is a tank-insulation degradation which would result in increased heat conduction to the helium. The insulating characteristics of the annular vacuum in tank was most likely degraded by the introduction of a contaminant (probably hydrogen) in extremely small concentrations (approximately  $10^{-6}$  pounds). These contaminants when vaporized can exponentially increase the thermal conductivity in proportion to their vapor pressure, as indicated by special tests. While loading helium into the tank, the contaminants would freeze upon the inner shell. In the frozen state, the pressure of the contaminant is too low to significantly affect the thermal conductivity. However, the flow check which preceded the cold-soak operation would vaporize the contaminants in the vicinity of the heat exchanger lines which pass through the annulus. The subsequent increase in thermal conductivity could cause the abnormally high pressure-rise rate observed during the cold soak. These vapors would slowly condense on the cold ( $10^{\circ}$  R) inner wall, resulting in the pressure rise rate dropping to the nominal level, as was observed. The rise rate would remain normal until the helium temperature increased above the vaporization temperature of the contaminant.

A screening test was devised for all future flight tanks to supplement normal helium tank testing. The purpose of this test is to determine the pressure rise rate for a wide range of helium temperatures from approximately 9° to 123° R. For a perfect tank, the steady-state rise rate should remain at approximately 8 psi/hour over the entire range of temperatures. The Apollo 14, 15, and 16 tanks have been subjected to the screening test, and each exhibit the same phenomena observed during Apollo 13, but to a lesser degree. For new tanks, the manufacturer will periodically analyze the gases removed from the vacuum jacket during pump down for possible contaminants. The pressure in the jacket will be measured 2 or 3 weeks after pumpdown to verify vacuum integrity.

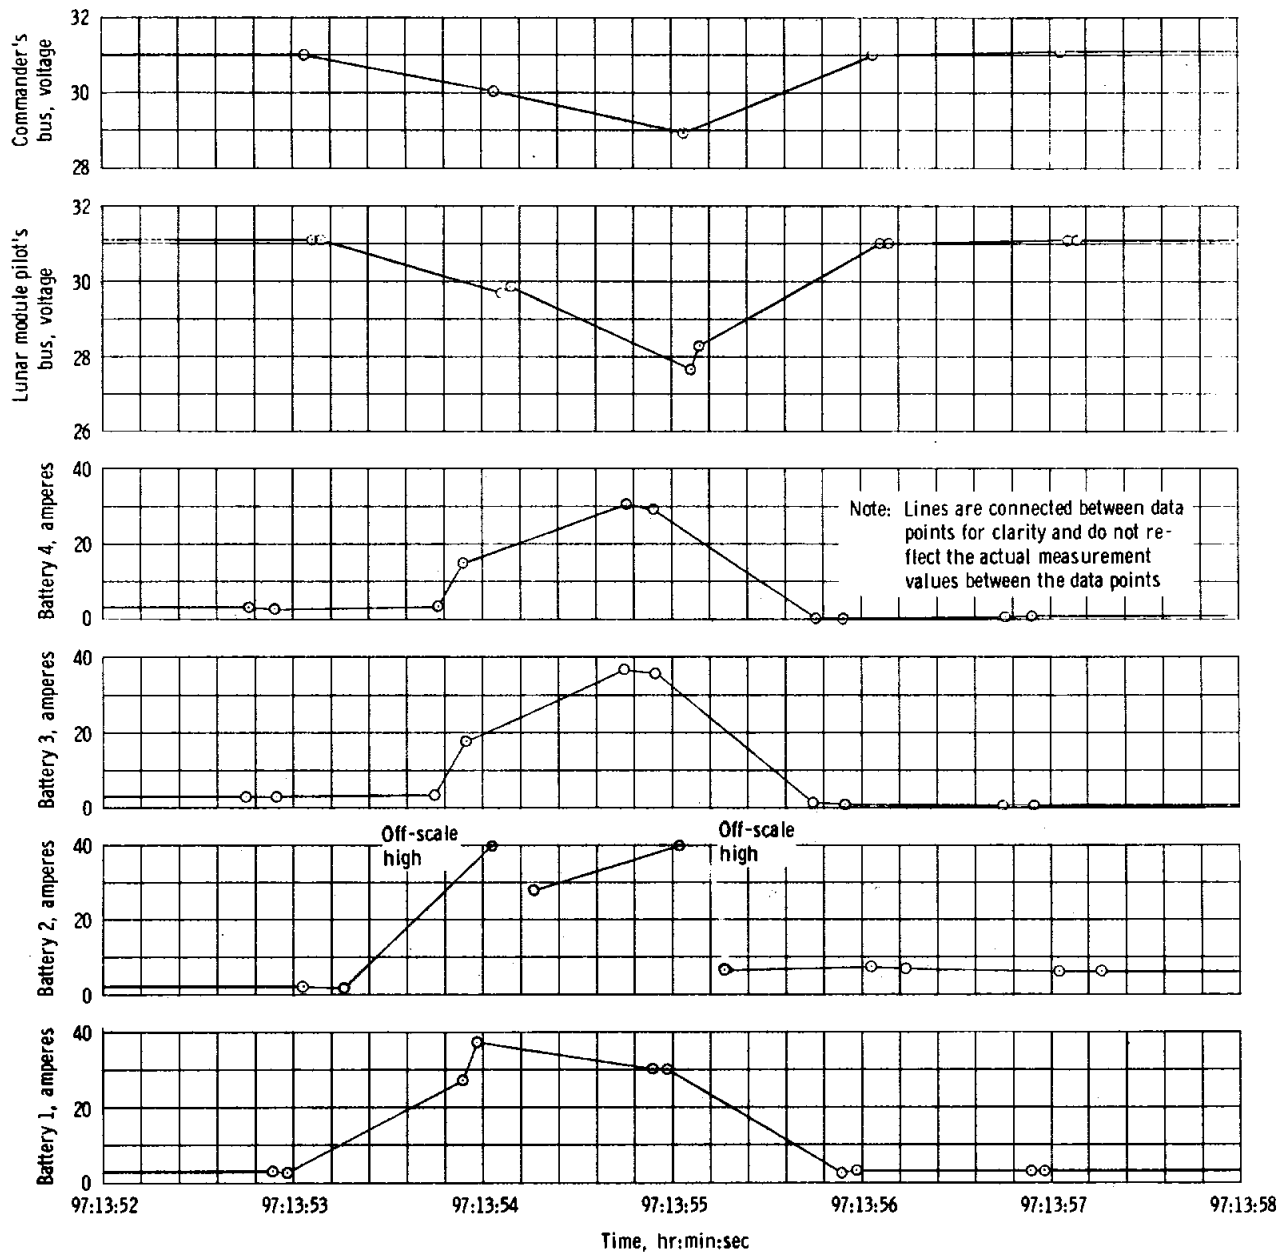
Figure 14-16.- Battery electrical transients.

The thumping noise occurred at about the same time as the current spikes. The current spikes show that a momentary short circuit existed in the Lunar-Module-Pilot side of the dc electrical system, which includes descent batteries 1 and 2 (fig. 14-16). The current surge was not of sufficient duration either to open the balance-load cross-tie circuit breakers, to display a reverse current indication, or to trip a battery-off relay as a result of an overcurrent condition.

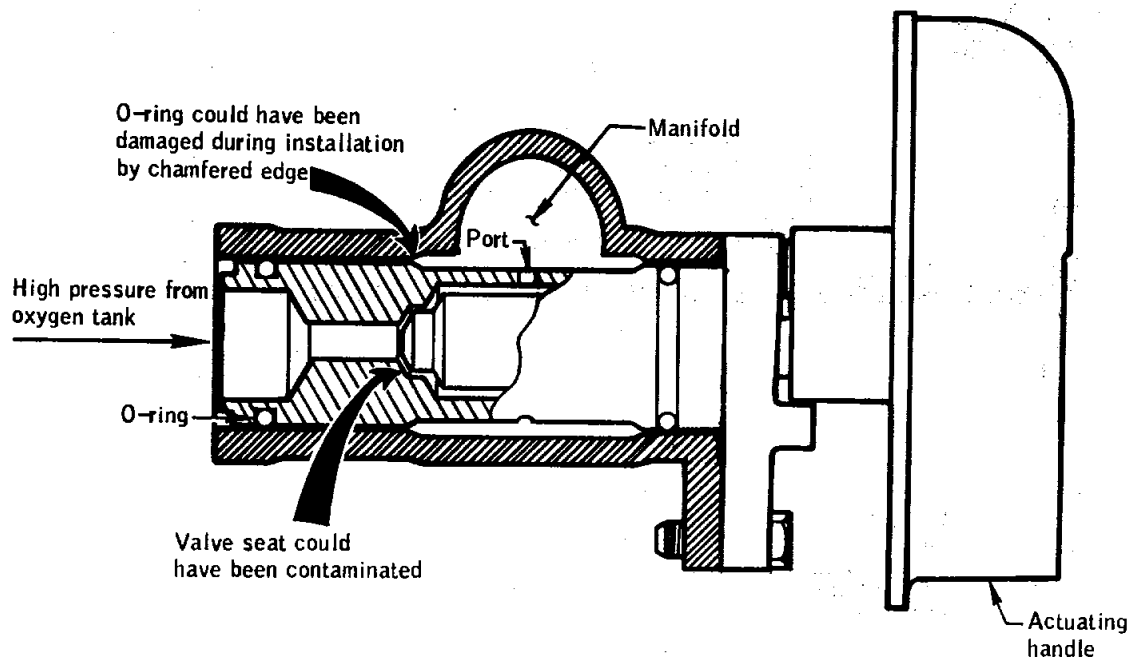
Figure 14-20.- Ascent stage tank shutoff valve.

(fig. 14-20) caused the leakage. When the valve is installed, the forward O-ring can be rolled and damaged when it passes the manifold port. In the other two valves, the cause was not identified and was assumed to be contamination.

compression allowed in the valve design would aggravate the tendency for the O-ring to roll during valve assembly.

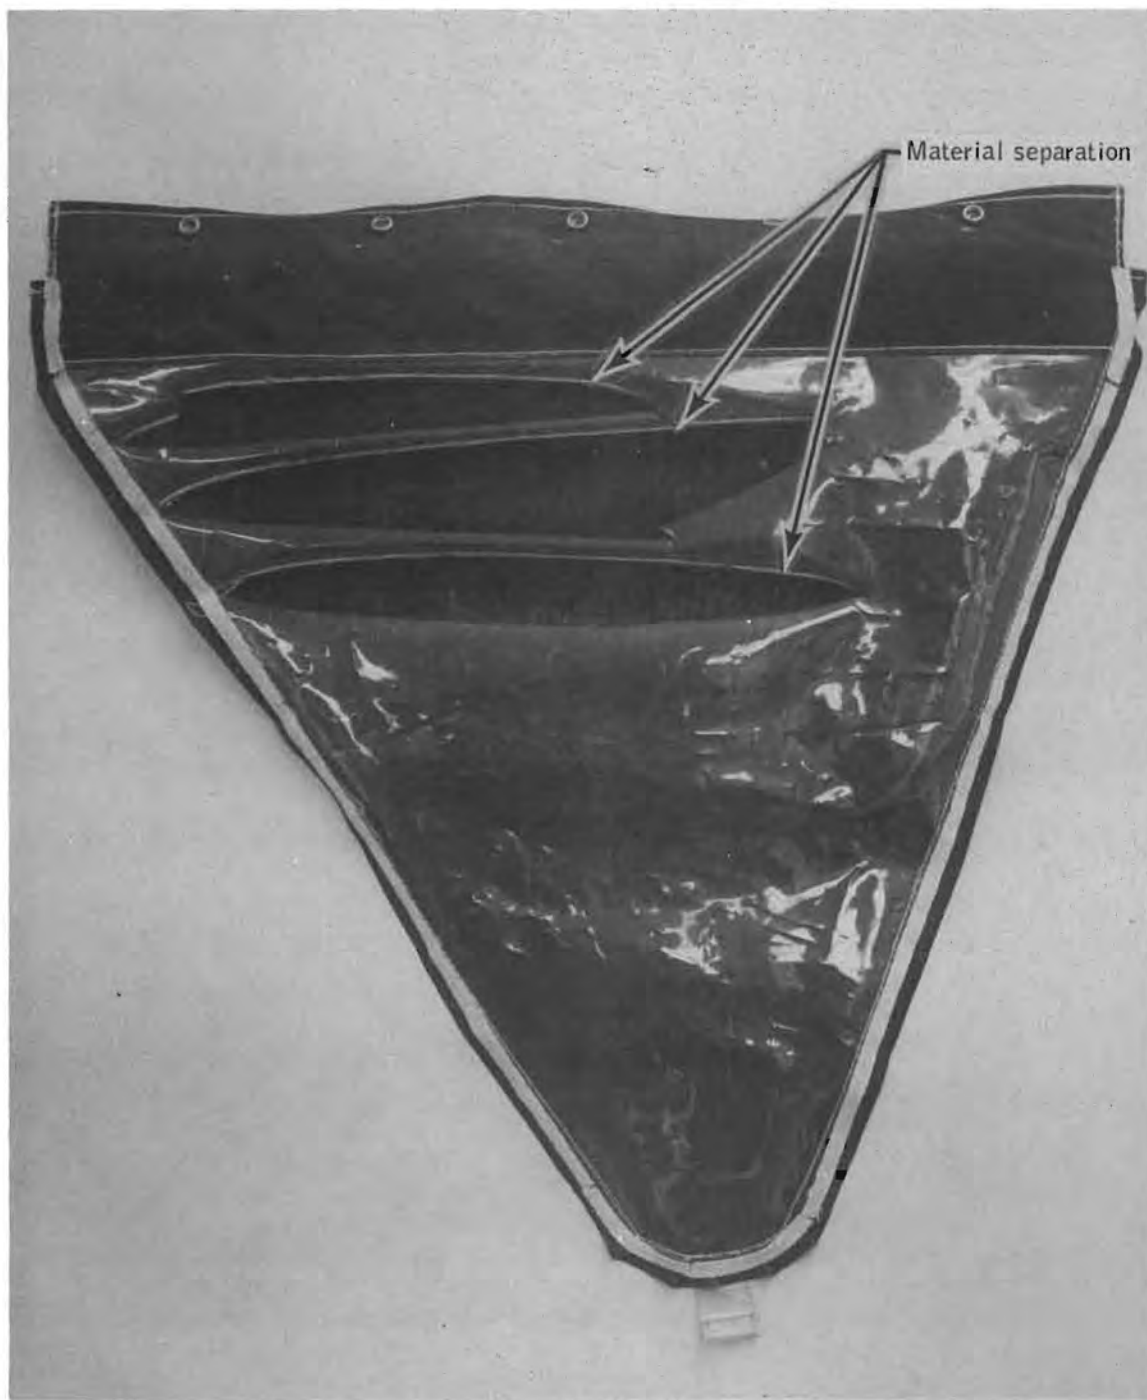
Figure 14-21.- Cracked left-hand window shade.

Cracking as a result of Aclar embrittlement has occurred before, therefore, the Apollo 13 shades were examined prior to flight. Since no cracks were found, the shades were approved for flight.
